DRAFT
Fountain Lake Sediment and Dredging
Assessment

Prepared for
Shell Rock River Watershed District

May, 2009

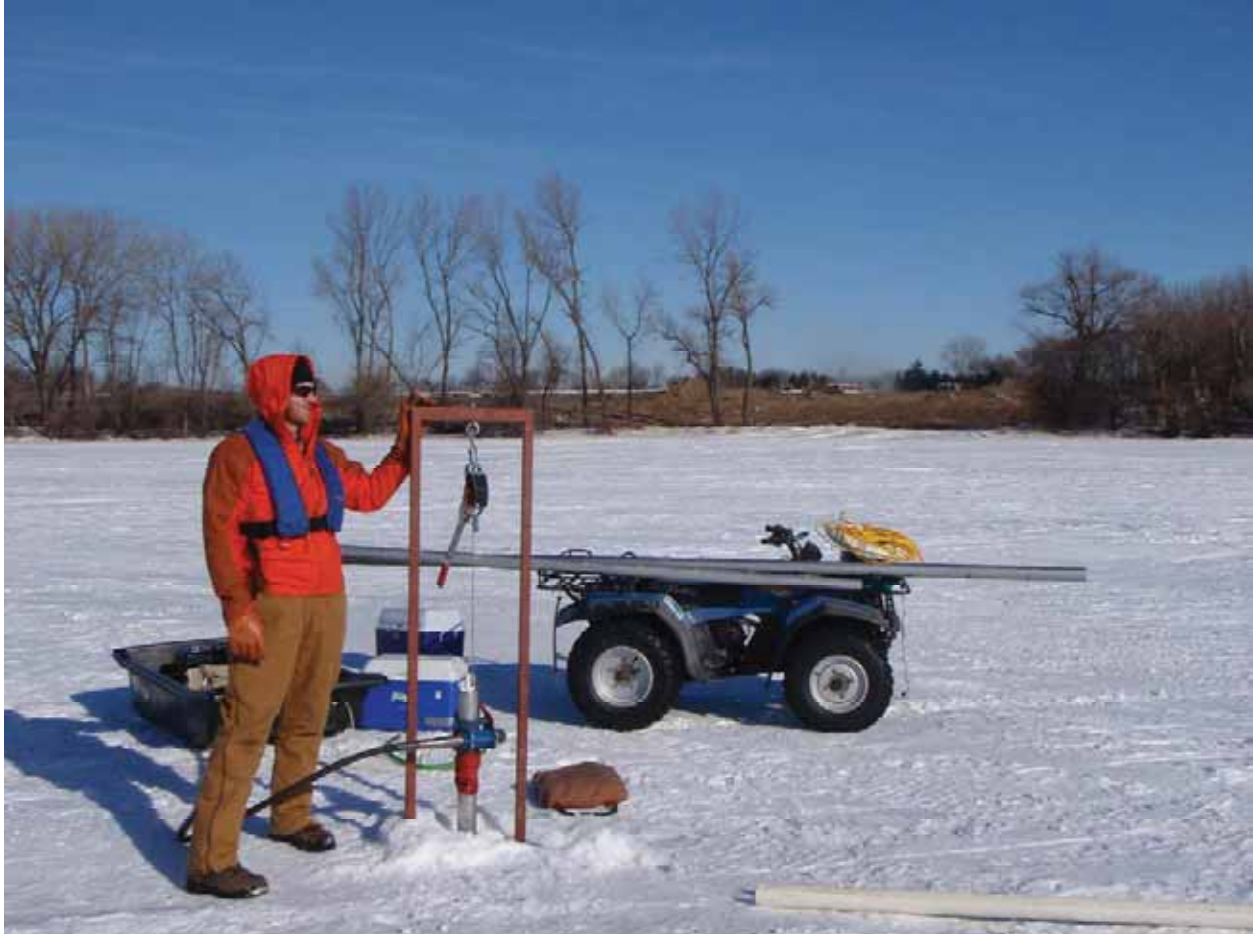
Site 2, Edgewater Bay. Landfill excavation in the background (north)

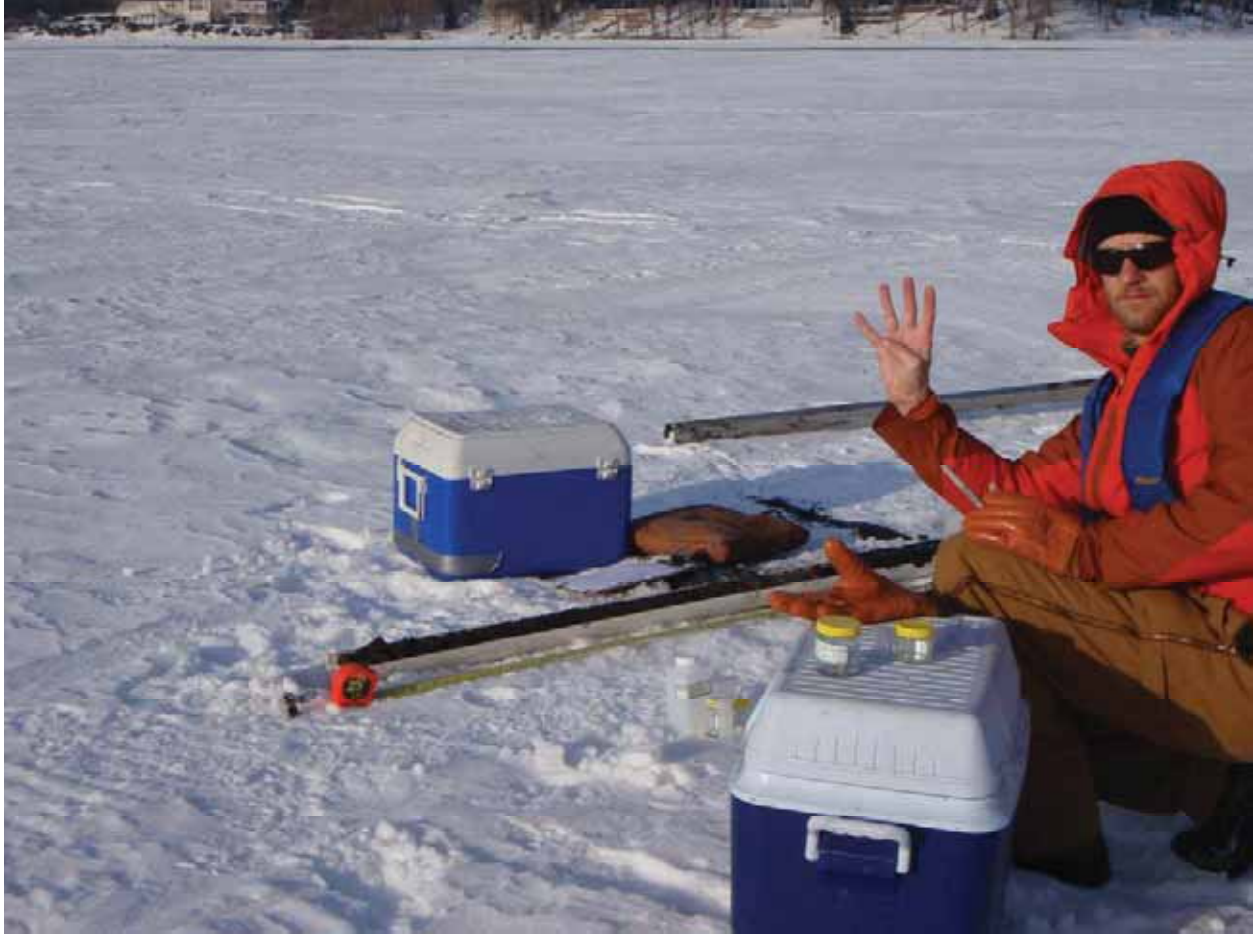
Site 4, Edgewater Bay. Open area in ice from aeration in the background.

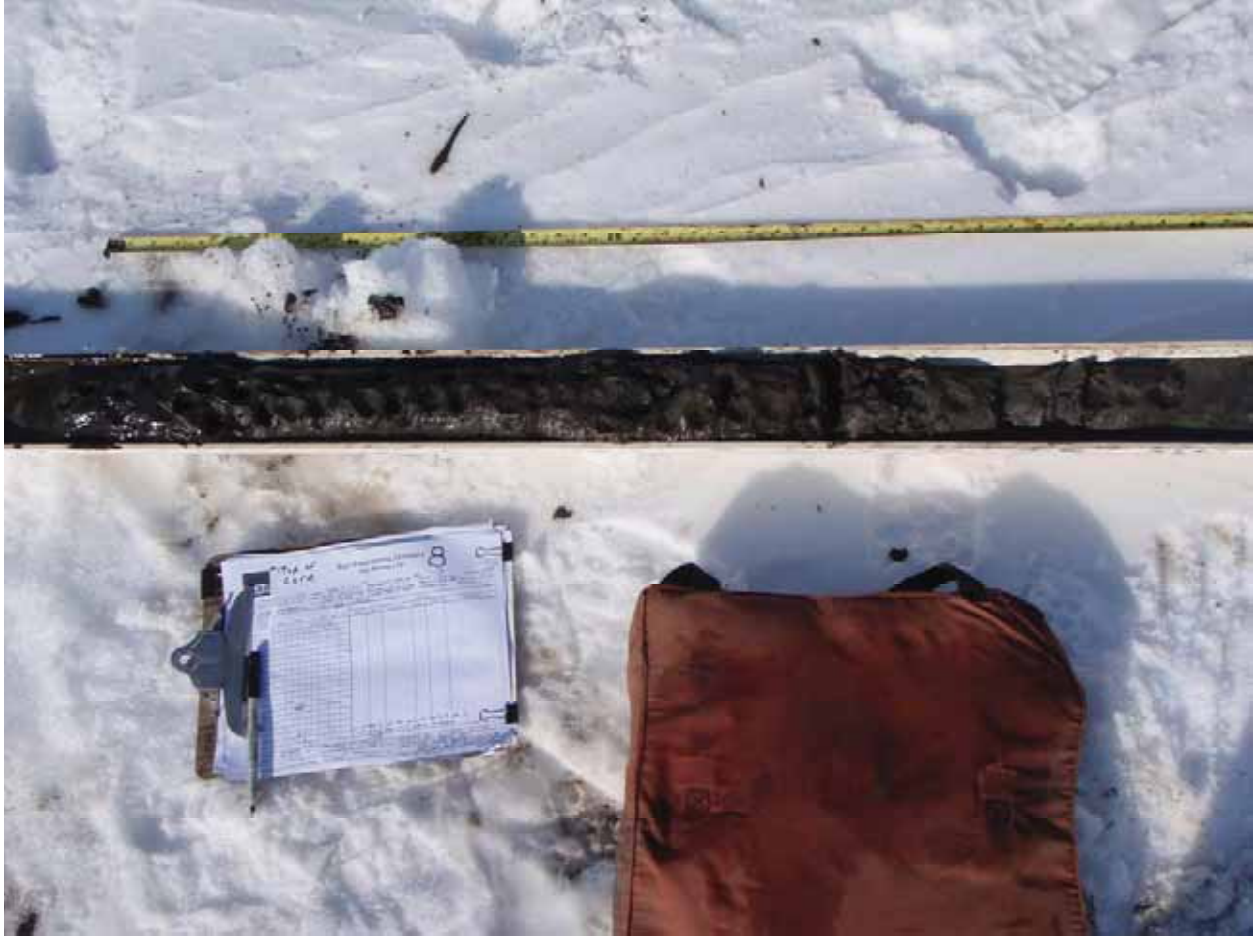
Site 8, Main Bay. Top section of the sediment core.
