2016 | Fountain Lake Water Monitoring Summary

Fountain Lake

Watershed area: 62,700 acres • Lake surface area: 555 acres
 Maximum lake depth: 9.5 feet • Average lake depth: 6.0 feet

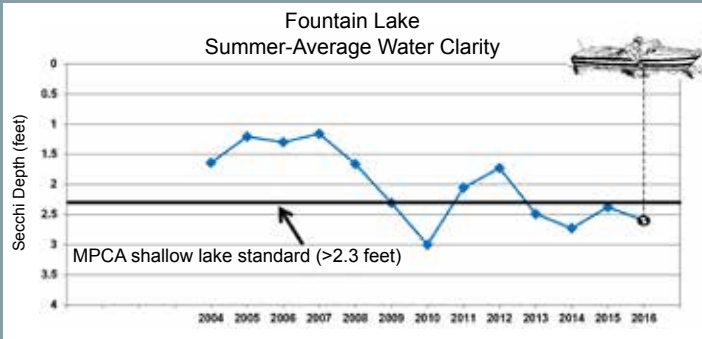
Water Clarity

Water clarity in Fountain Lake has been monitored regularly since 2004. The clarity of the water is measured by lowering a black-and-white disk (Secchi disk) into the water and identifying the depth at which the disk is no longer visible. As shown in the figure, Fountain Lake's summer-average clarity in 2016 met the Minnesota Pollution Control Agency's (MPCA) standard for shallow lakes in southern Minnesota, the fourth year in a row that the clarity standard was met.

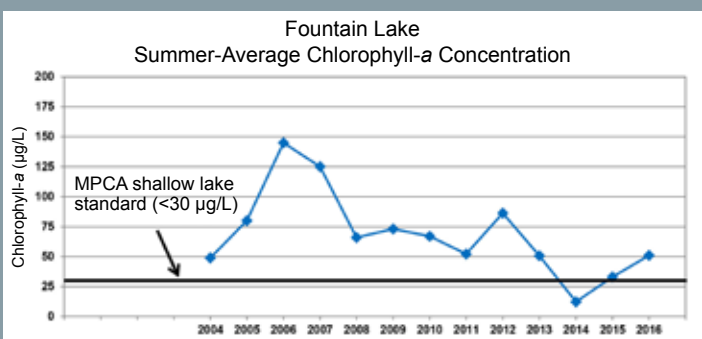
Chlorophyll-a

Chlorophyll-a, the main photosynthetic pigment in algae, has been monitored by the SRRWD since 2004. Summer-average chlorophyll-a concentrations in 2016 did not meet the MPCA's standard for shallow lakes in southern Minnesota. Samples collected from Edgewater Bay had lower chlorophyll-a concentrations than Main Bay, particularly after July 1. Data from the two sites are combined to calculate a single summer-average value for the lake.

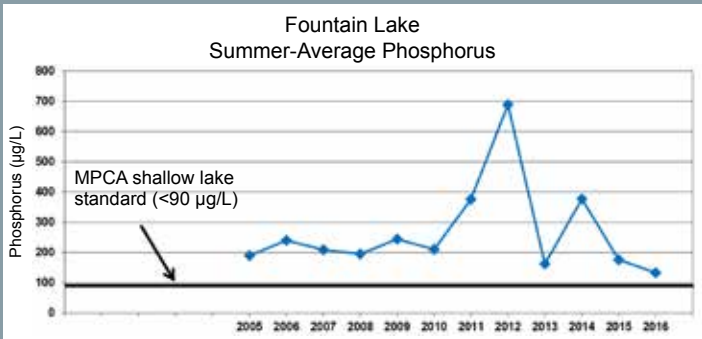
Phosphorus is a plant nutrient that stimulates the growth of algae in lake water. Although the 2016 summer-average phosphorus concentration was the lowest recorded since the SRRWD began its monitoring program, it failed to meet the MPCA standard. Sources of phosphorus to Fountain Lake include stormwater runoff from the lake's direct watershed, water from upstream lakes and tributary streams, and the release of phosphorus from lake sediments (see reverse).

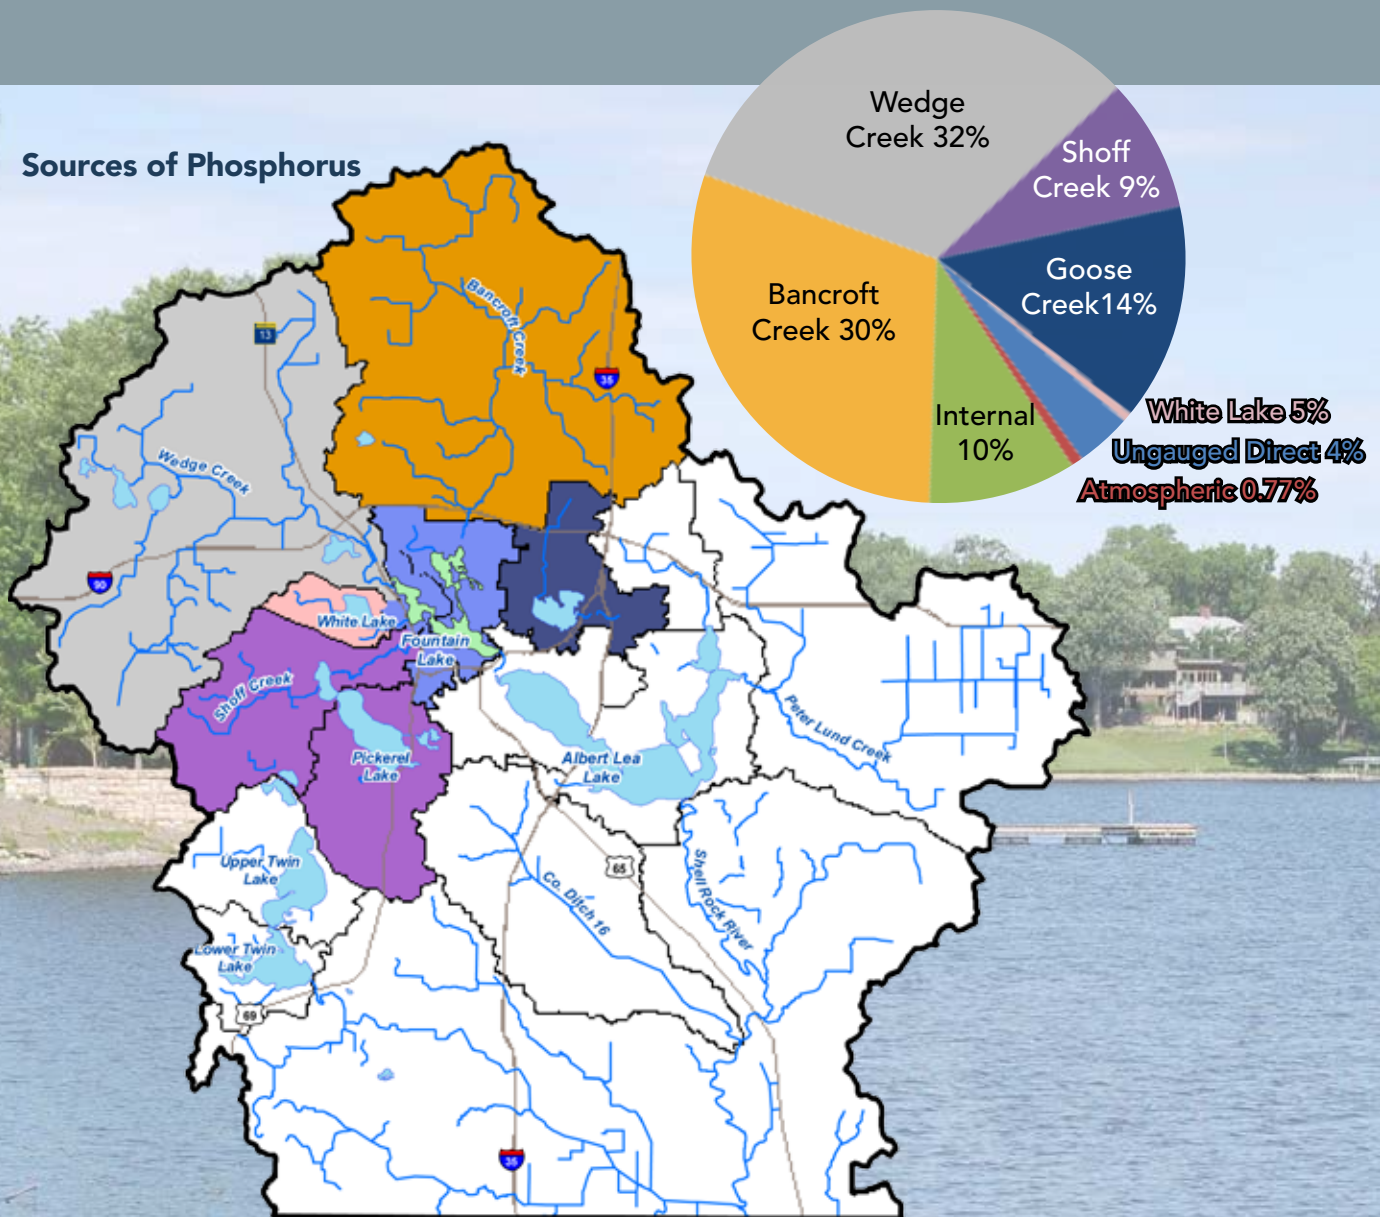
Sources of Phosphorus

The Wedge Creek and Bancroft Creek watersheds were the largest sources of phosphorus to Fountain Lake during the 2016 monitoring season, contributing 32 percent and 30 percent of the phosphorus load, respectively. When it rains, stormwater runoff carries dissolved phosphorus, soil, and the phosphorus attached to soil particles into nearby lakes and streams. Above-average rainfall and runoff during 2016 resulted in large amounts of phosphorus being carried to Fountain Lake.

Internal phosphorus loading is another major phosphorus contributor to Fountain Lake. Like many lakes, Fountain Lake accumulates phosphorus in its bottom sediment from the settling of soil particles and dead organisms. Internal loading occurs as phosphorus in the sediment is reintroduced into the lake water and becomes available again for uptake by floating plants and algae. This complex process can be affected by water temperature, oxygen, pH, wind mixing, and disturbance by bottom-feeding fish such as carp. In many years, internal loading is the largest contributor of phosphorus to Fountain Lake. During 2016, internal loading made up a smaller—but still significant—portion of Fountain Lake's phosphorus load.
